Compilation of local Marine Hazards

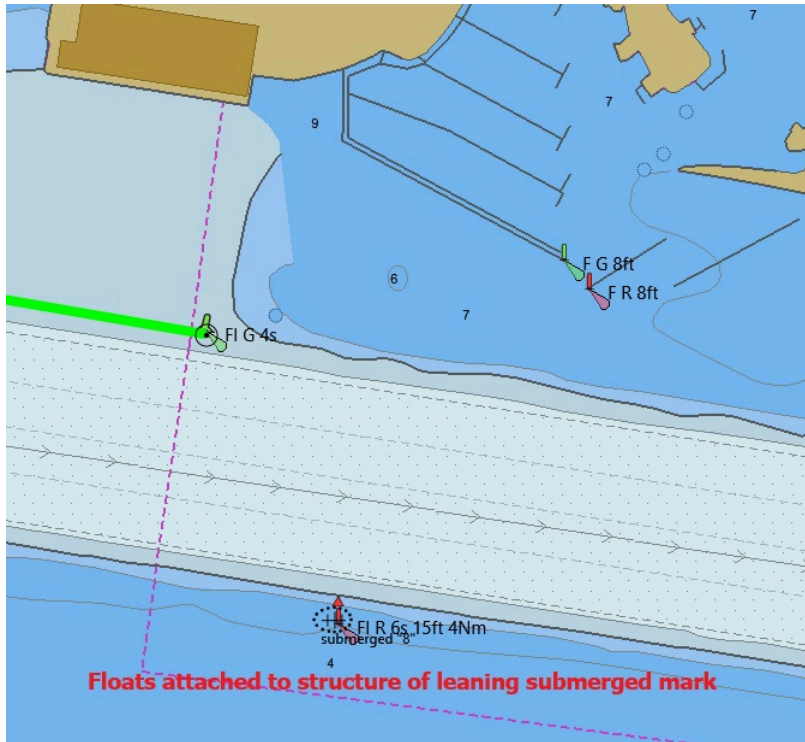
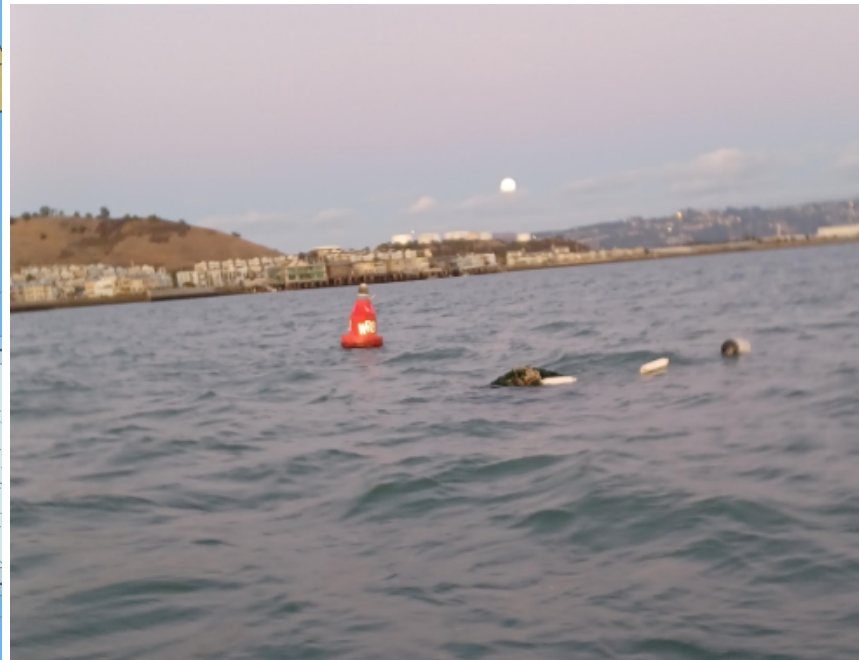
Hazard at "8", just across from the RYC entrance: the marker is laying down at an angle, south of the temporary buoy. The floats are tied to the top structure of the submerged marker. The light cage shows at -0.5ft tide

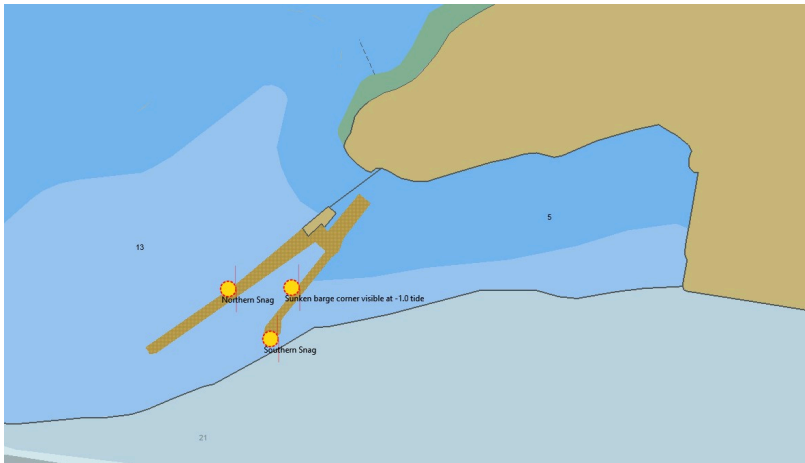
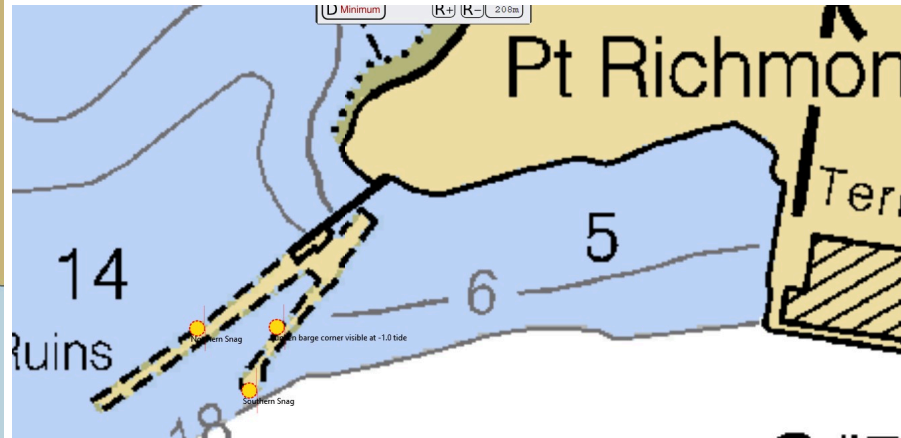
Remains of ferry landing demolition: There are two snags which are visible at about a -1.0ft tide. They are marked by orange floats. The northeastern corner of a sunken barge is marked with a dock bumper closer in towards the remaining part of the landing.

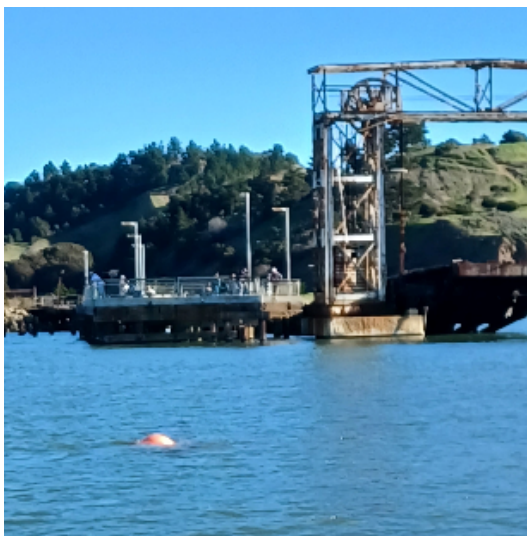
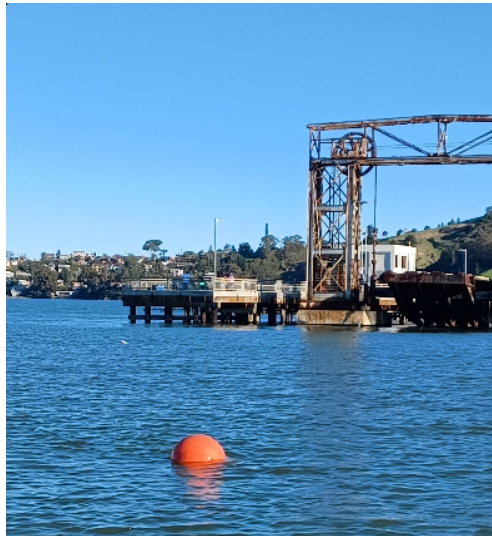
North snag and South snag. Tide is 7ft, no slack in line to snag. You can see a small white float indicating the position of the sunken barge in the photo on the right.

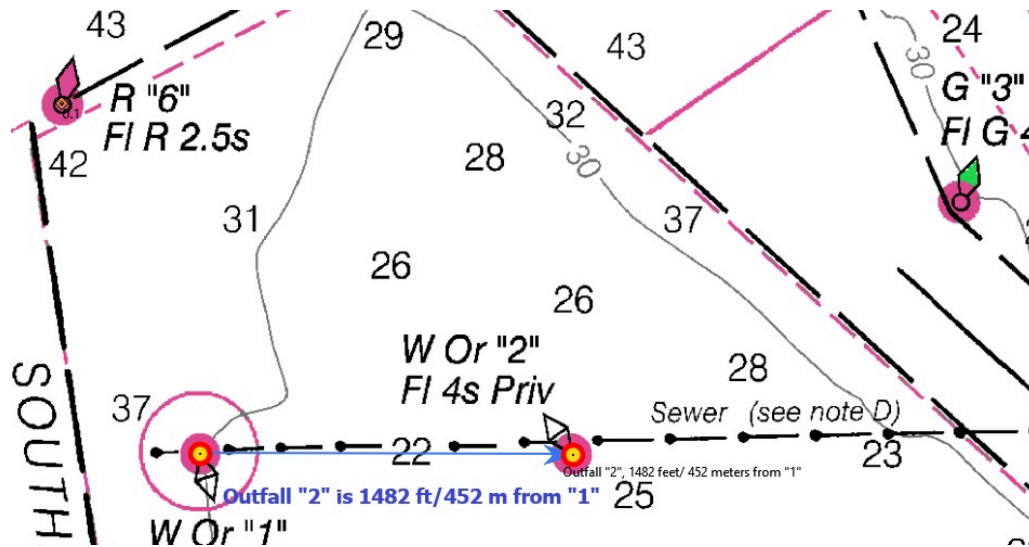
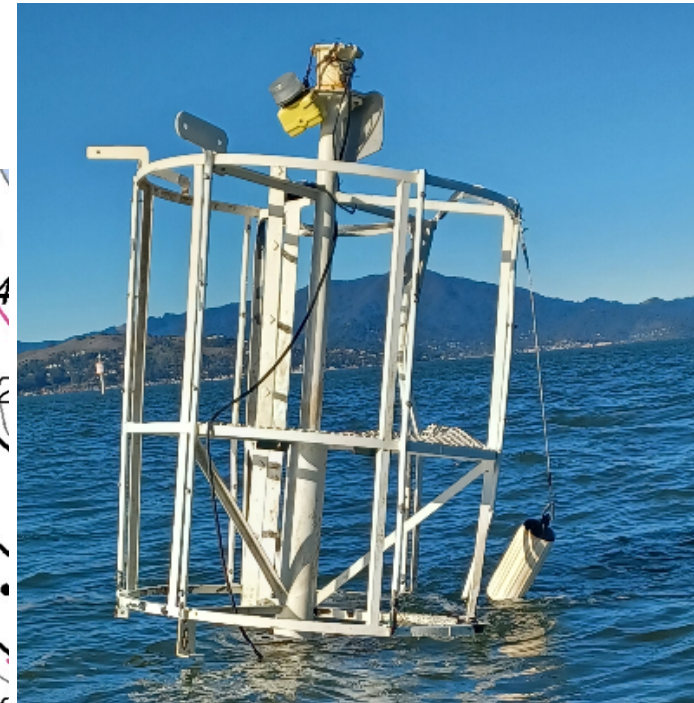
Richmond sewage outfall pipe markers: "2" has no light and can be submerged during high tide and strong currents: The photo was taken at a 6.8ft tide, 0.8kt current. You can see "1" in the background.

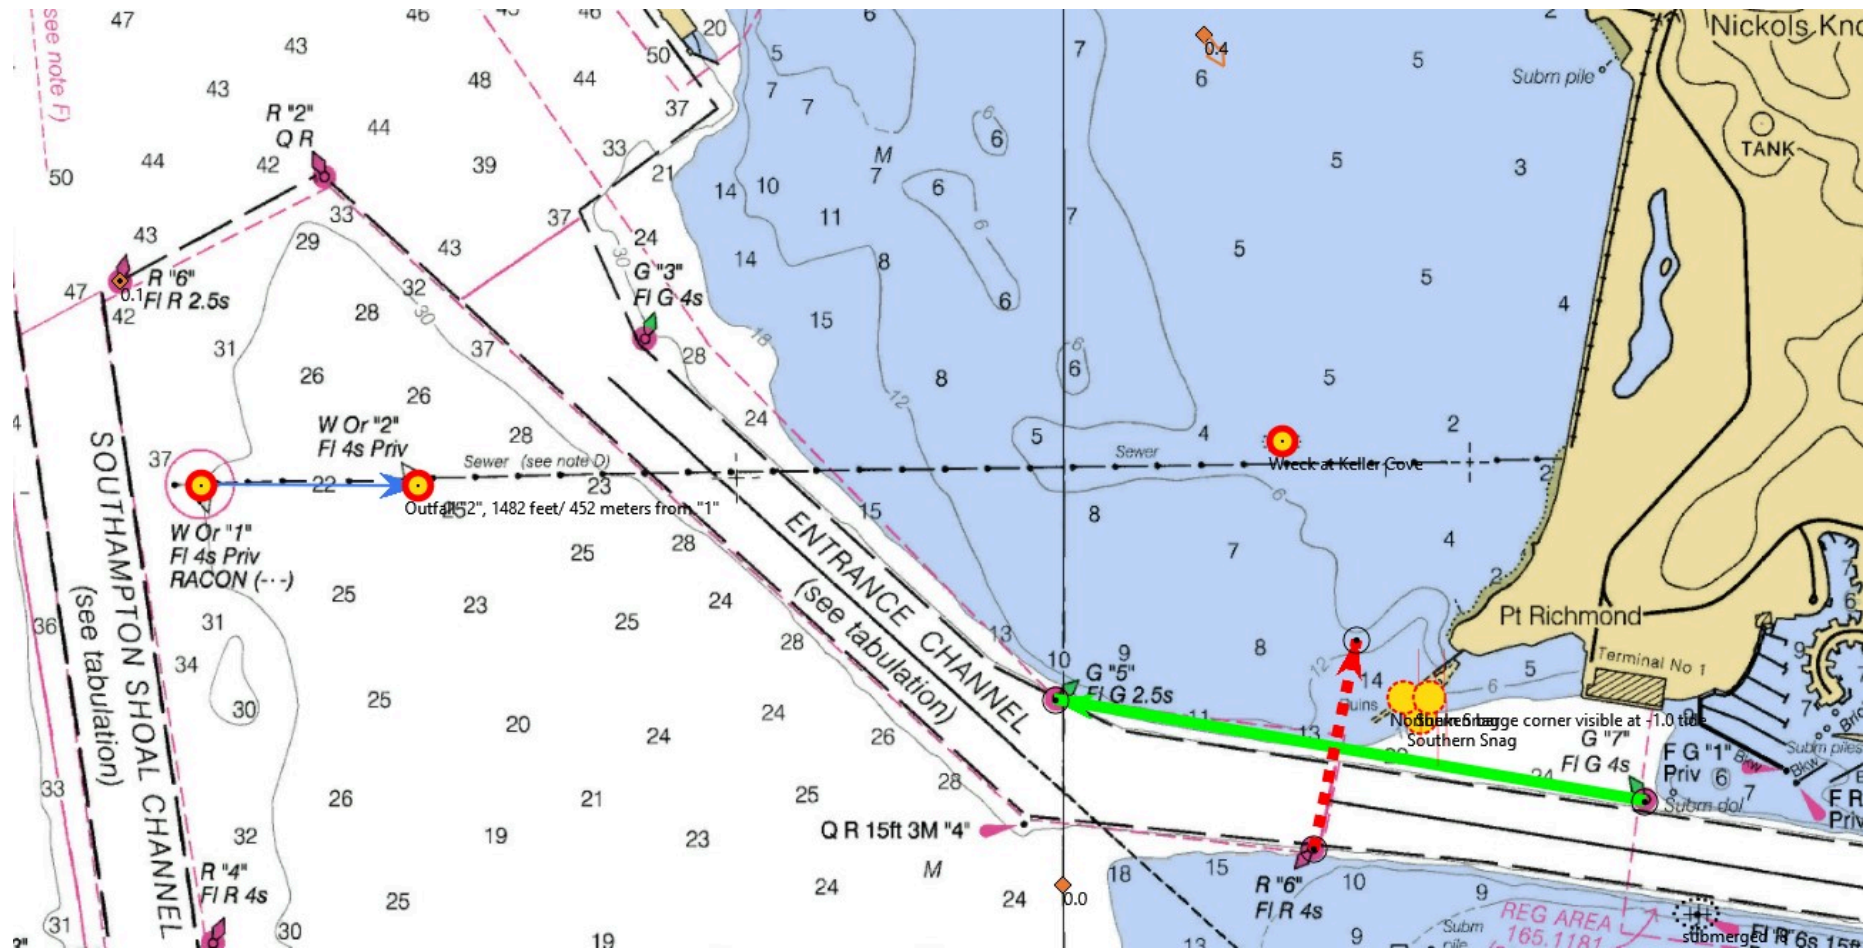
Combined hazards on the chart. Note the Wreck in Keller Cove.

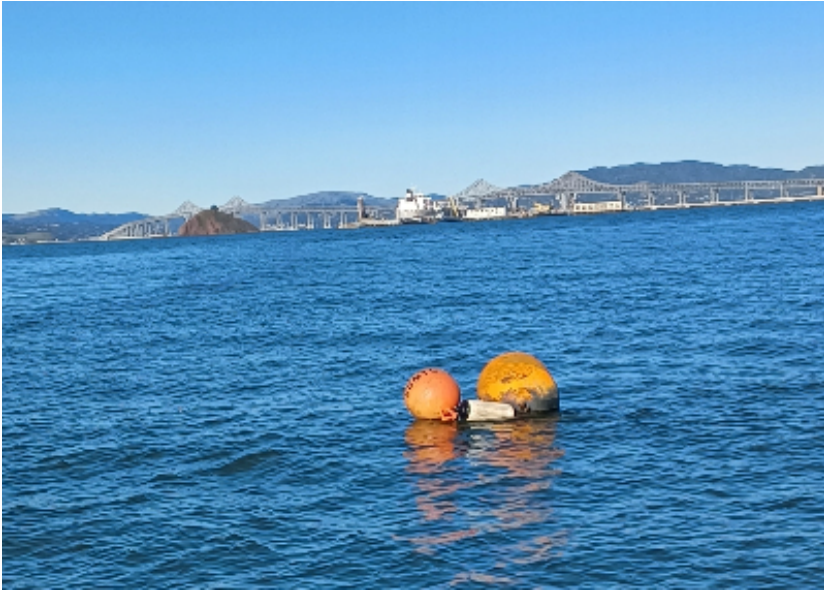
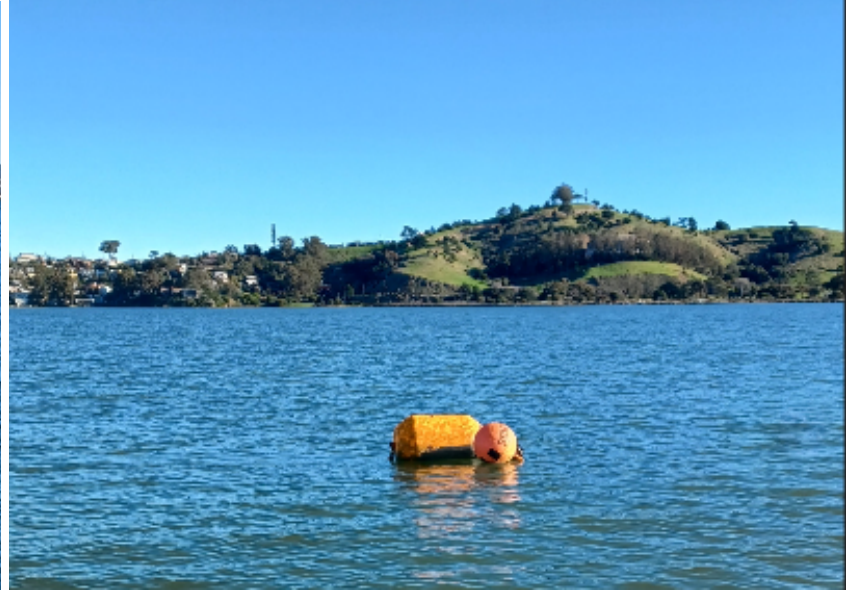
The wreck at Keller Cove: It is sitting near vertical, bow up. The tip of the bow shows at about a 0ft tide.
